May 31, 2006  
J.N. 211-05

**Subject: Summary of Geotechnical Observation and Testing During Temporary Repair of the Ferrocarril Landslide, City of Mission Viejo, California.**

Reference: Petra Geotechnical, Inc., 2005, Preliminary Geotechnical Investigation of the Ferrocarril Landslide, City of Mission Viejo, California, J.N. 173-05, dated September 30.

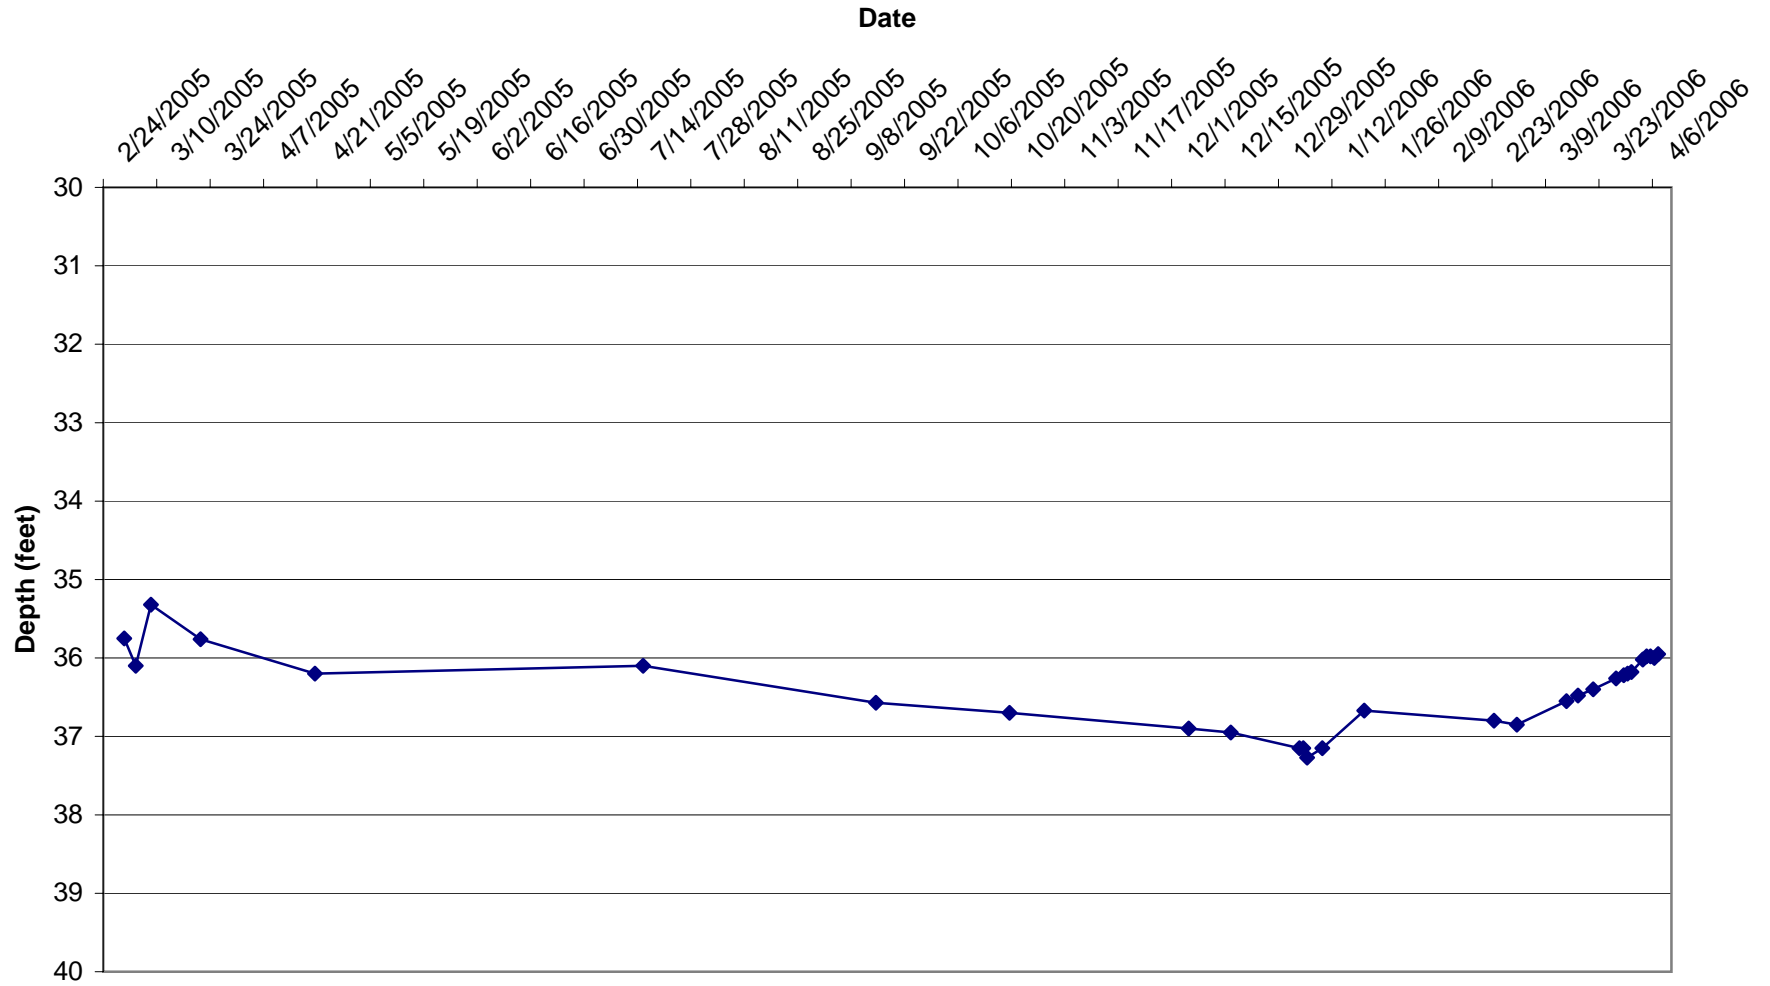
**FERROCARRIL LANDSLIDE  
GROUNDWATER MONITORING DATA  
BORING B-3A**

During the preliminary geotechnical investigation a temporary groundwater monitoring well was installed in boring BA-3 (see Plate 1). Periodic measurements of the groundwater level were recorded and are presented in Appendix C along with historical rainfall data from nearby Lake Mission Viejo. The weather station at Lake Mission Viejo is located about 2 ¾ miles northeast of the site at an elevation of about 700 feet.

The groundwater level in the well did show some response to rainfall during a series of storms that occurred in March and early April 2006. However, the total rainfall amounts and intensity were not as great as those encountered during the January 2005 rainstorms. These data are provided for use during final repair of the landslide, which is the responsibility of others.

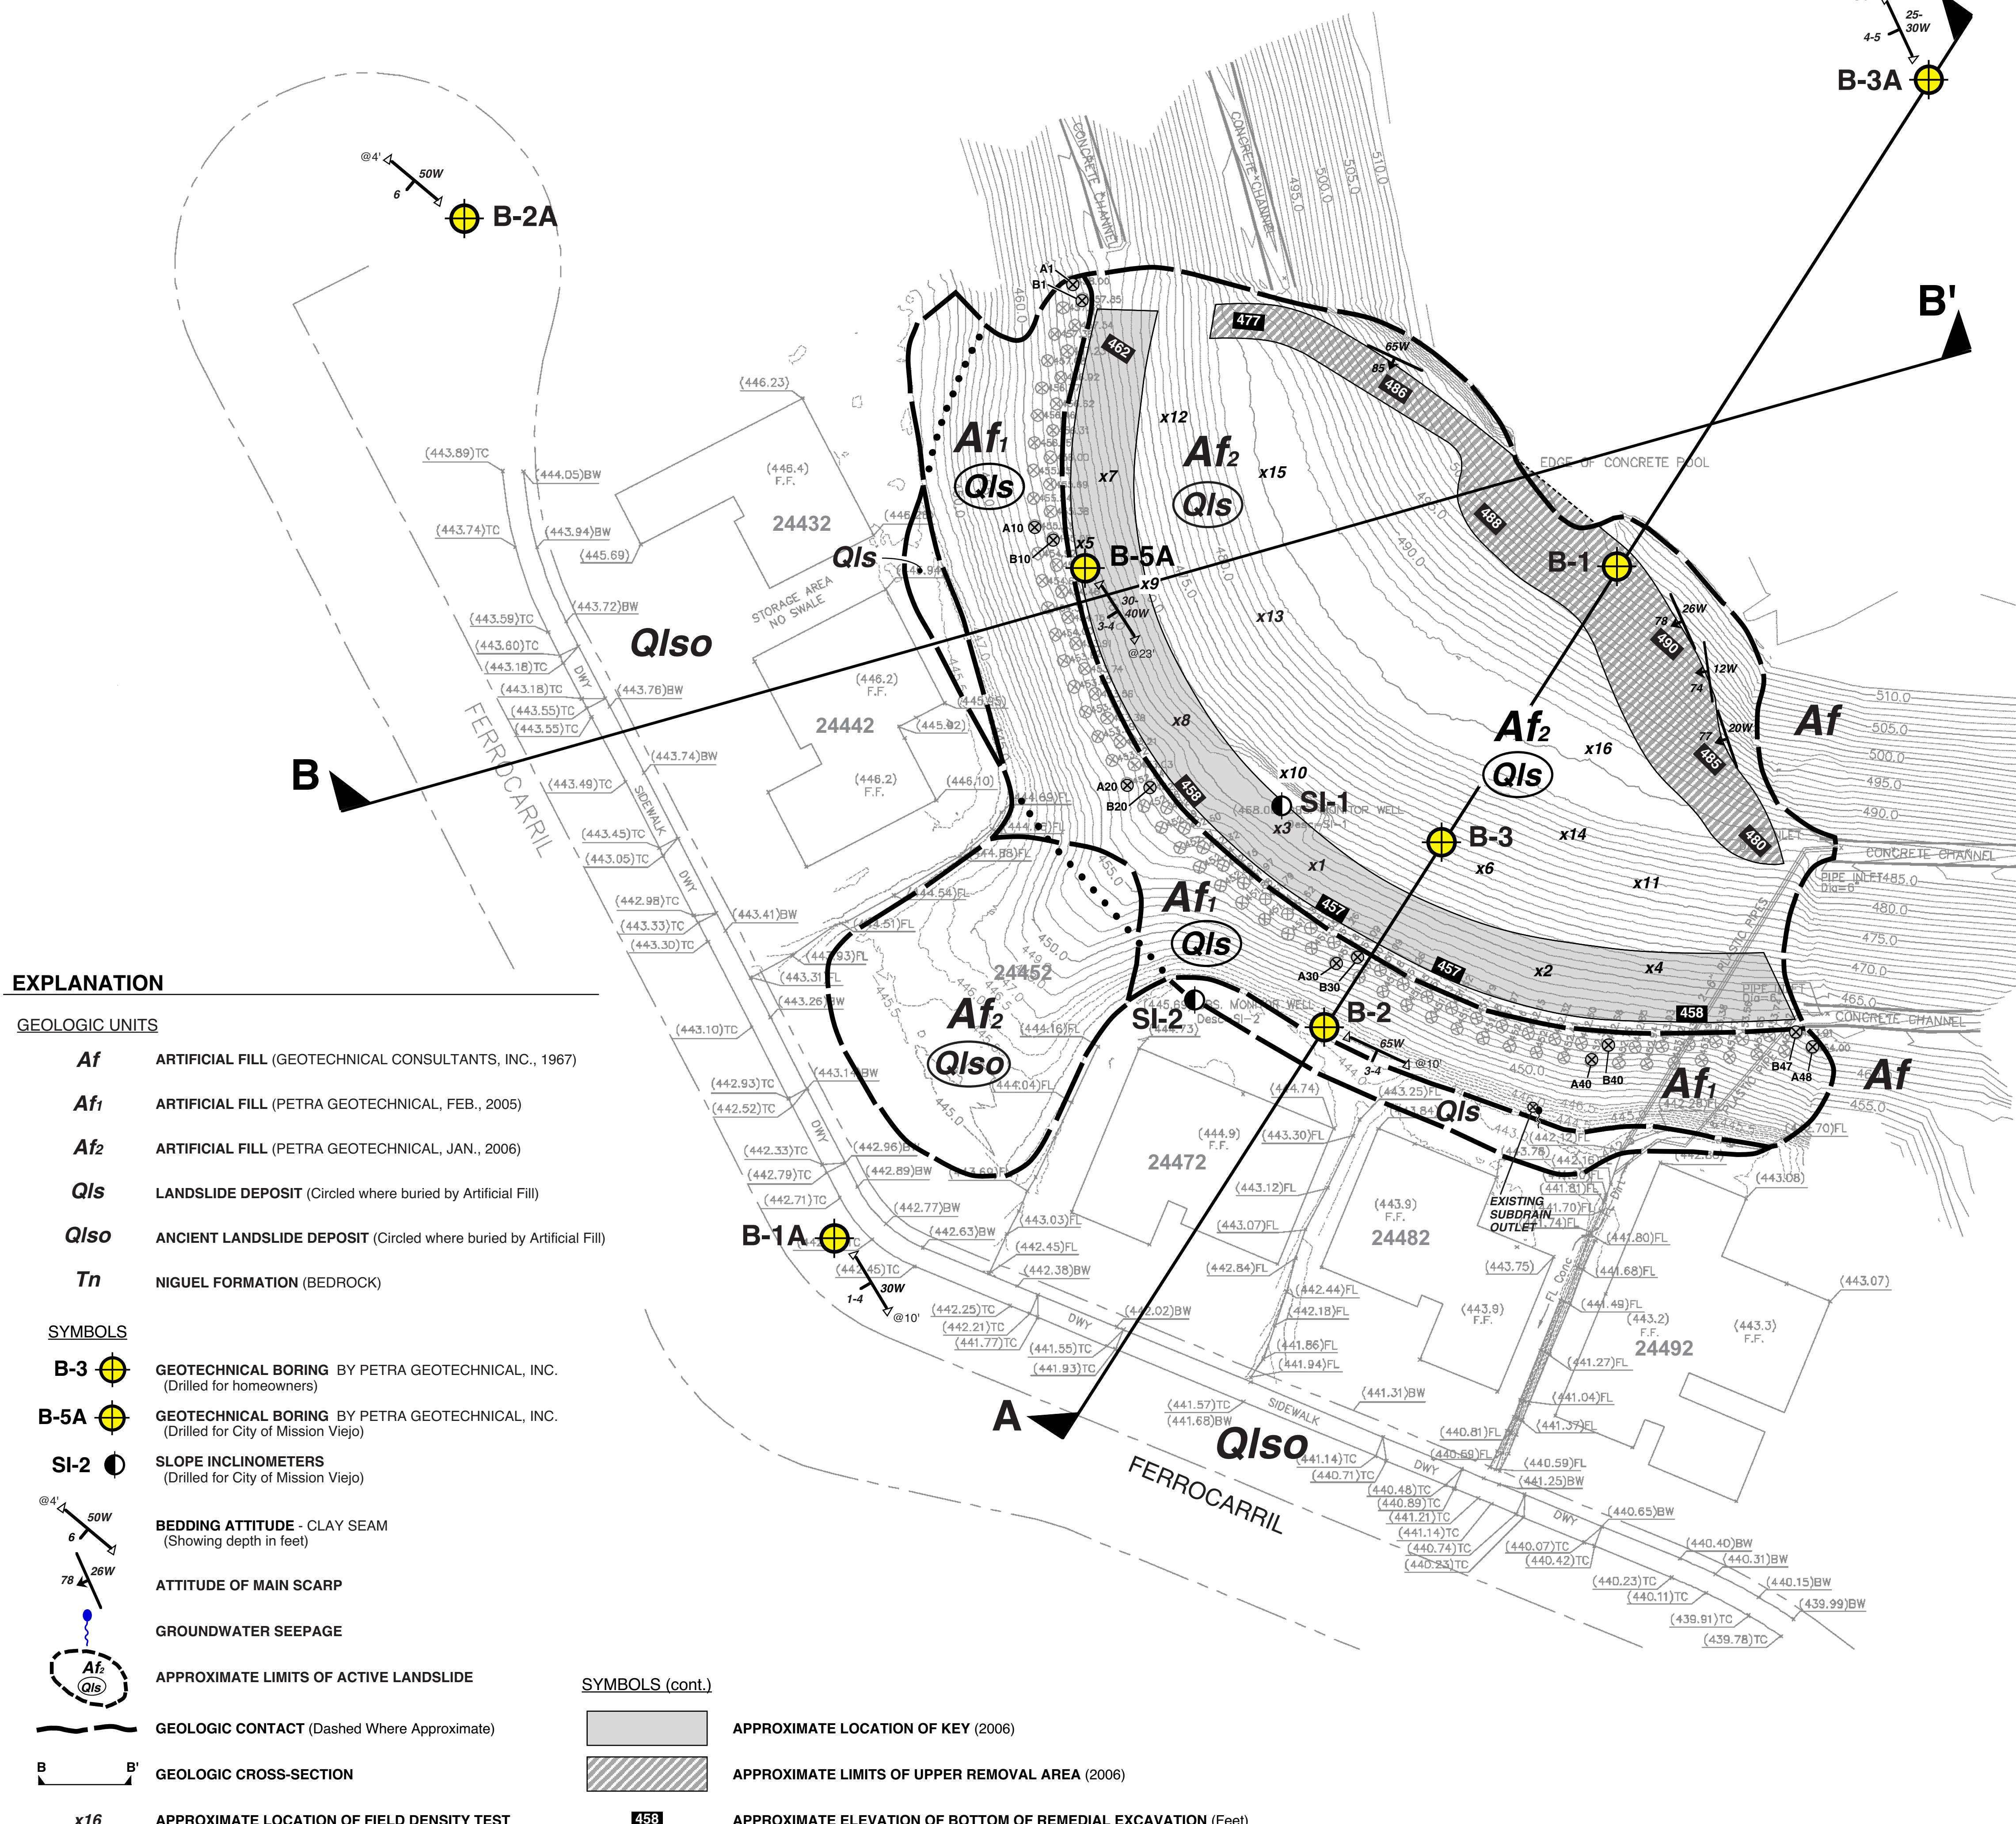
**PETRA GEOTECHNICAL, INC.**  
**JN 211-05** **MAY, 2006**  
**GEOTECHNICAL MAP** **PLATE 1**

Re-grading of the slope was conducted after the caissons were completed and commenced on January 10, 2006 and completed on February 3, 2006. The main purposes for re-grading the slope were to protect the structures along Ferrocarril from damage as a result of surficially unstable soil in front of the caissons that had crept up against the structure located at 24492 Ferrocarril and was threatening several others, and to provide better surficial drainage conditions and allow for installation of temporary erosion control measures. The conceptual grading plan was developed by L&A and grading operations were performed by LT Engineering, Inc. Re-grading of the slope included trimming the face of the lower and uppermost portions of the slope, construction of a stabilization key, fill placement, removal and recompaction of landslide materials below the main scarp of the landslide, and installation of an erosion control blanket. The approximate limits of the keyway and upper remedial removal area are depicted on Plates 1 and 2.

Landslide debris located directly below the main scarp of the landslide was removed by an excavator to the approximate elevations shown on Plate 1. The main purpose of the removal operation was to reduce the amount of future settlement of the landslide debris located in this area. After the removal was completed, the underlying landslide debris was track-walked by an excavator. Fills were then placed by track-walking of the excavator, but were not tested for relative compaction.

Supplemental geologic structural data obtained during this phase of work includes depths and attitudes along the landslide rupture surface and the main scarp of the landslide (see Plates 1 and 2). The landslide rupture surface was observed in boring BA-5 and in several of the caisson borings, and found to lie at elevations of about 438 to 440 feet, which is within one to two feet of the elevations used for caisson design. Mapping and structural attitudes recorded along the main scarp of the landslide also coincided with the geologic model used for caisson design.

Groundwater was also observed flowing from a pre-existing subdrain outlet located along the toe of the slope behind the residence at 24482 Ferrocarril (see Plate 1). The outlet was composed of a 6-inch diameter corrugated metal pipe that was installed in 1967 when the slope was constructed. A flow rate of about ¼ gpm (gallon per minute) was measured from the pipe. An earthen swale was constructed to control the seepage from the pipe and direct it to the surface drain located between 24482 and 24492 Ferrocarril.
