May 31, 2006  
J.N. 211-05

**Subject: Summary of Geotechnical Observation and Testing During Temporary Repair of the Ferrocarril Landslide, City of Mission Viejo, California.**

Reference: Petra Geotechnical, Inc., 2005, Preliminary Geotechnical Investigation of the Ferrocarril Landslide, City of Mission Viejo, California, J.N. 173-05, dated September 30.

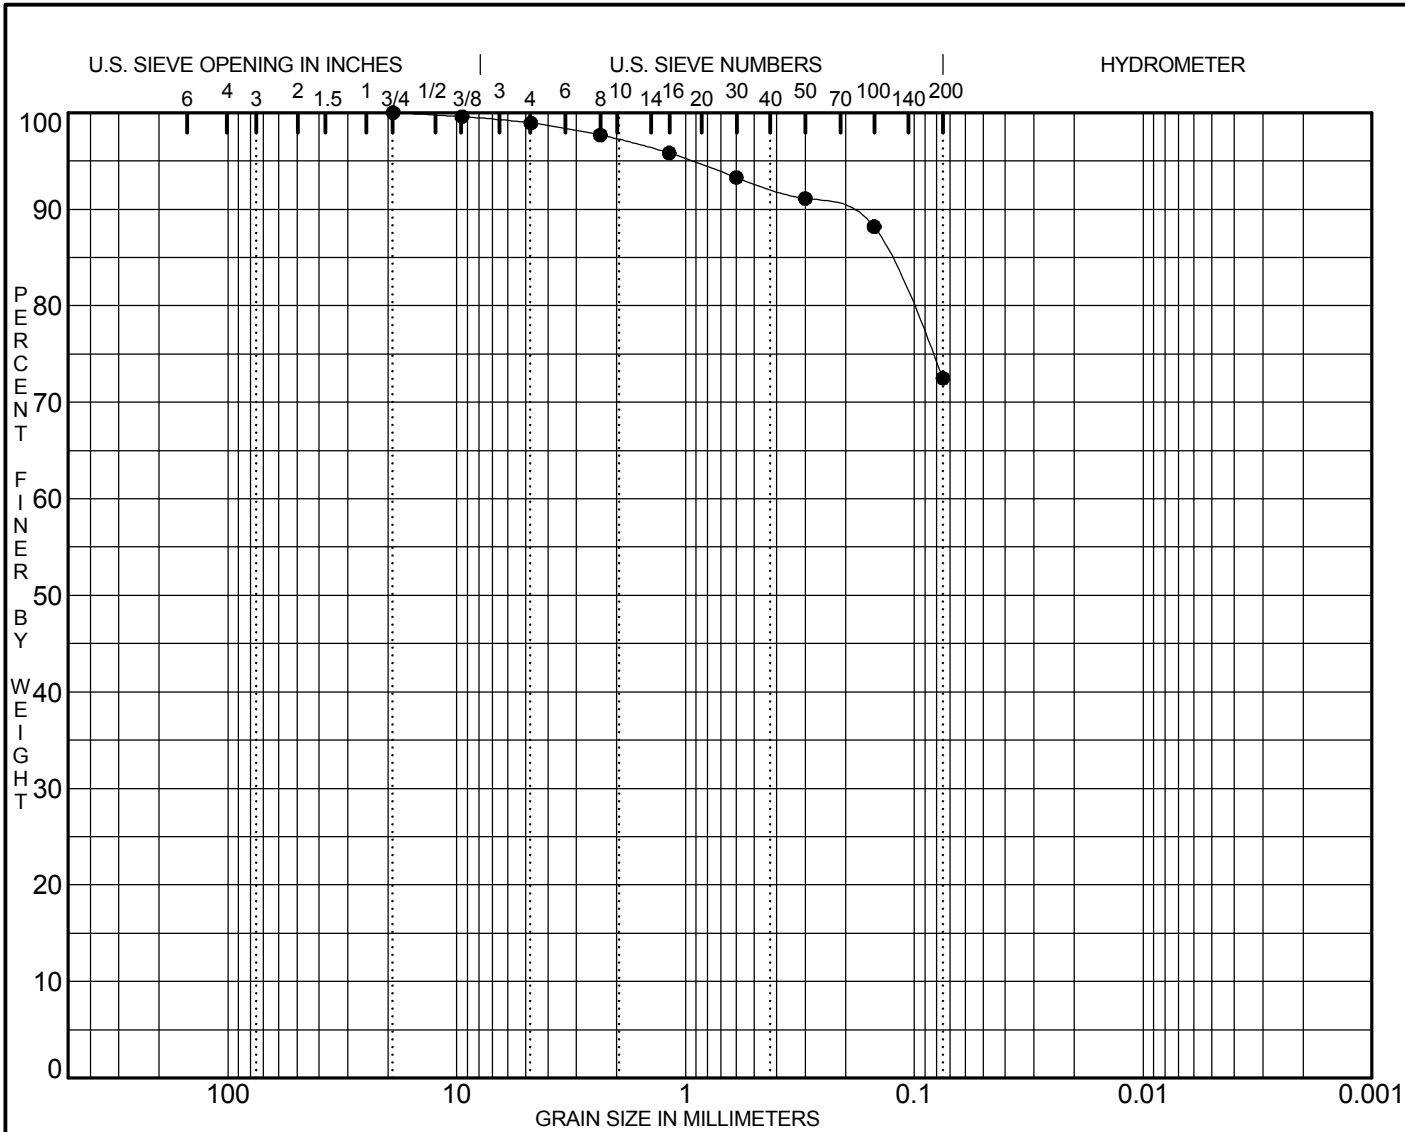
GRAIN SIZE - V1 211-05.GPJ PETRA.GDT 4/21/06

Specimen Identification	Classification	MC%	LL	PL	PI	Cc	Cu
● SI-1 0.0	Silty Clay/Clayey Silt (CL-ML)

Specimen Identification	D100	D60	D30	D50	%Gravel	%Sand	%Silt	%Clay
● SI-1 0.0	19.00				1.1	26.4	72.5

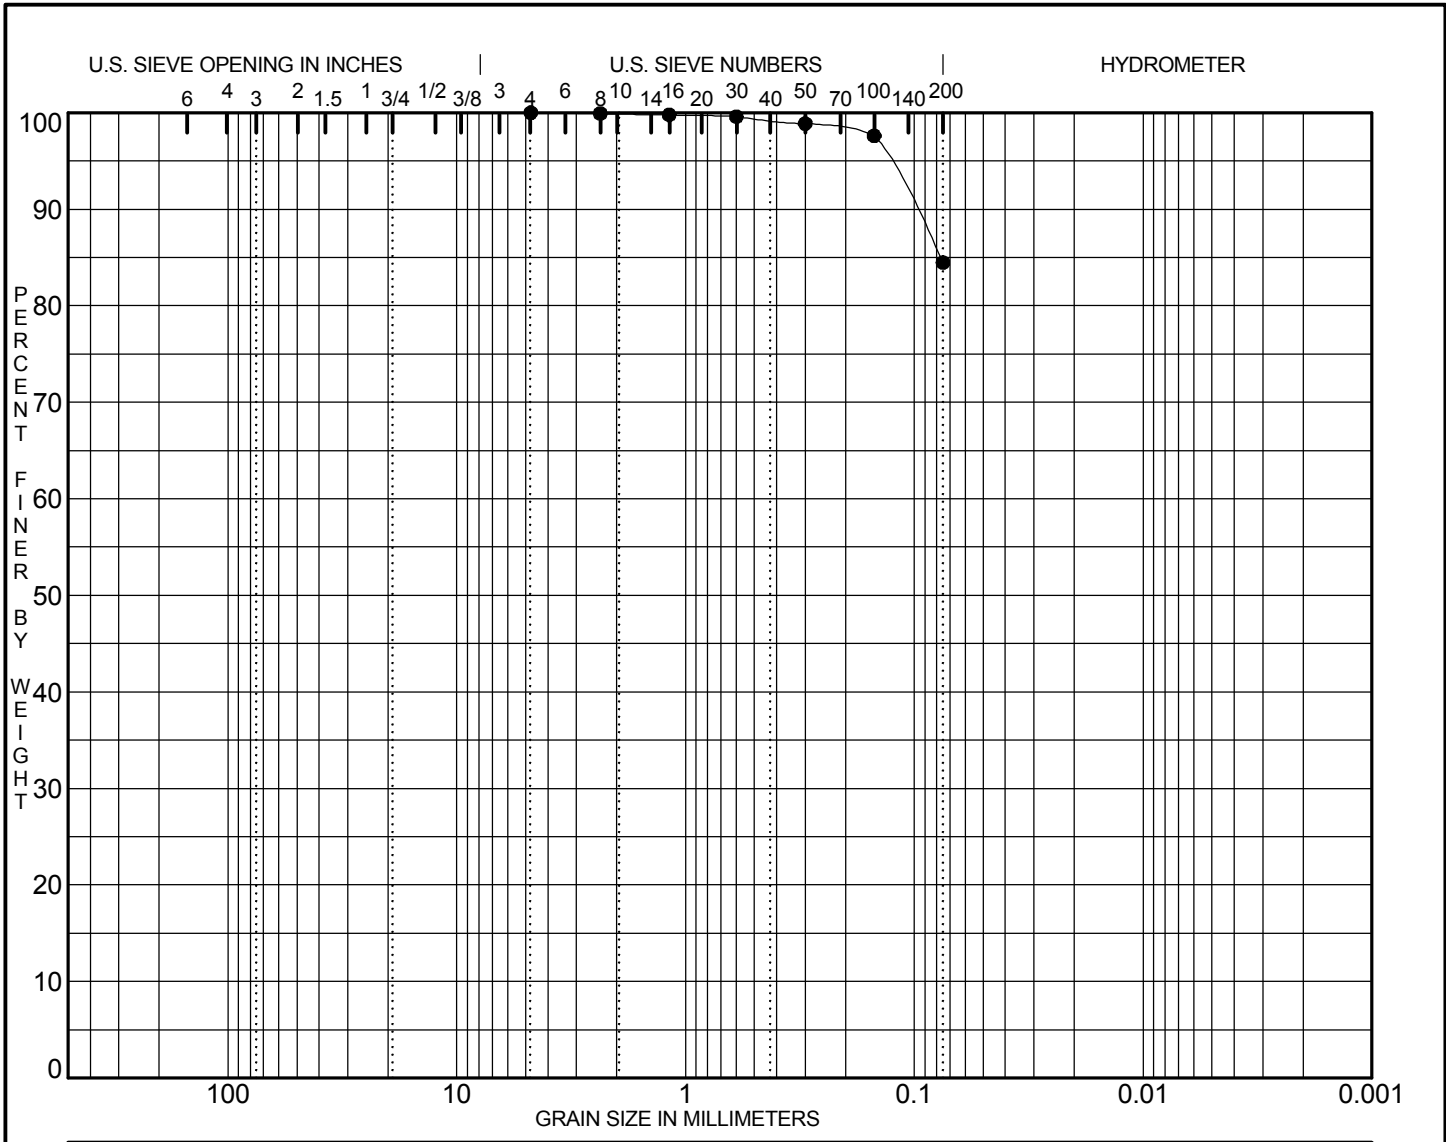
Specimen Identification	Classification	MC%	LL	PL	PI	Cc	Cu
● SI-2 0.0	Silty Clay/Clayey Silt (CL-ML)
